Report of the  
**PRESIDENTIAL  
COMMISSION**

*on the Space Shuttle  
Challenger Accident*

June 6th, 1986  
Washington, D.C.

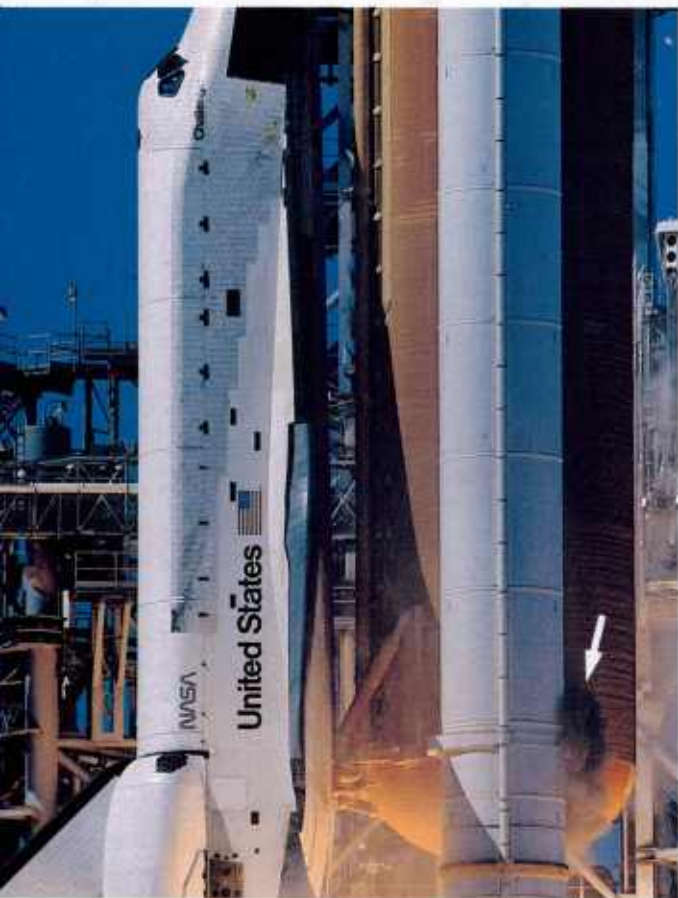
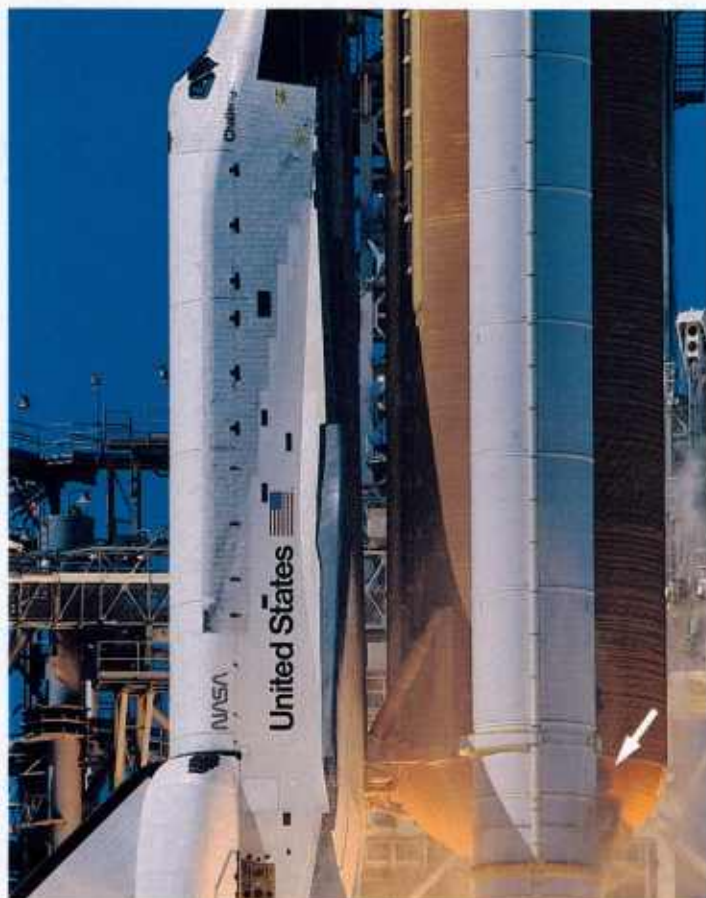
Immediately after solid rocket motor ignition, dark smoke (arrows) swirled out between the right hand booster and the External Tank. The smoke's origin, behavior and duration was approximated by visual analysis and computer enhancement of film from five camera locations. Consensus: smoke was first discernible at .678 seconds Mission Elapsed Time in the vicinity of the right booster's aft field joint.

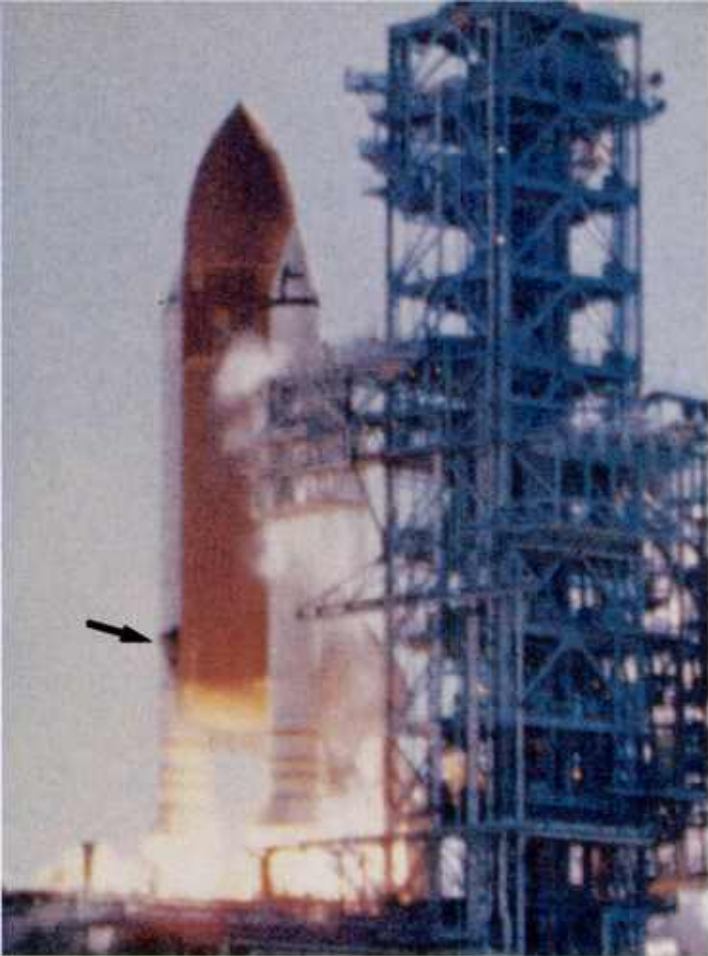
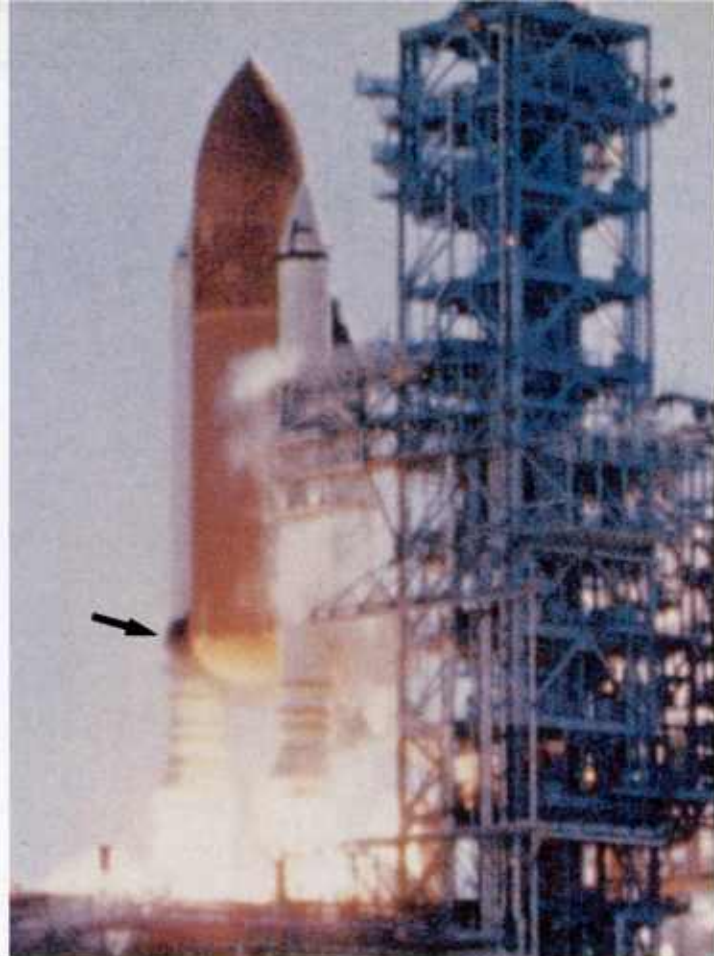
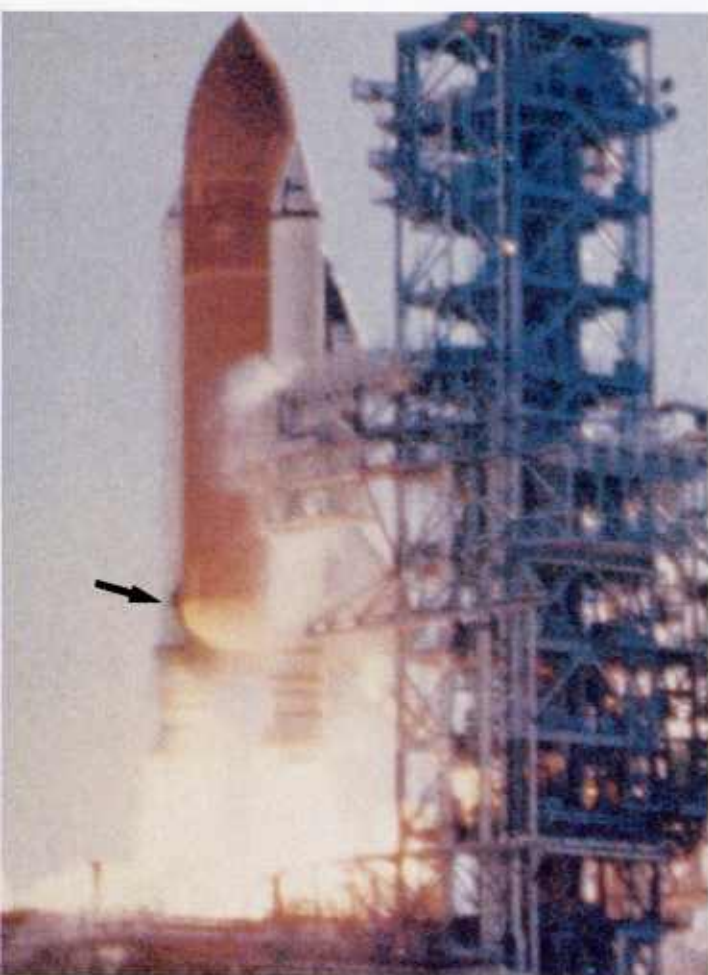
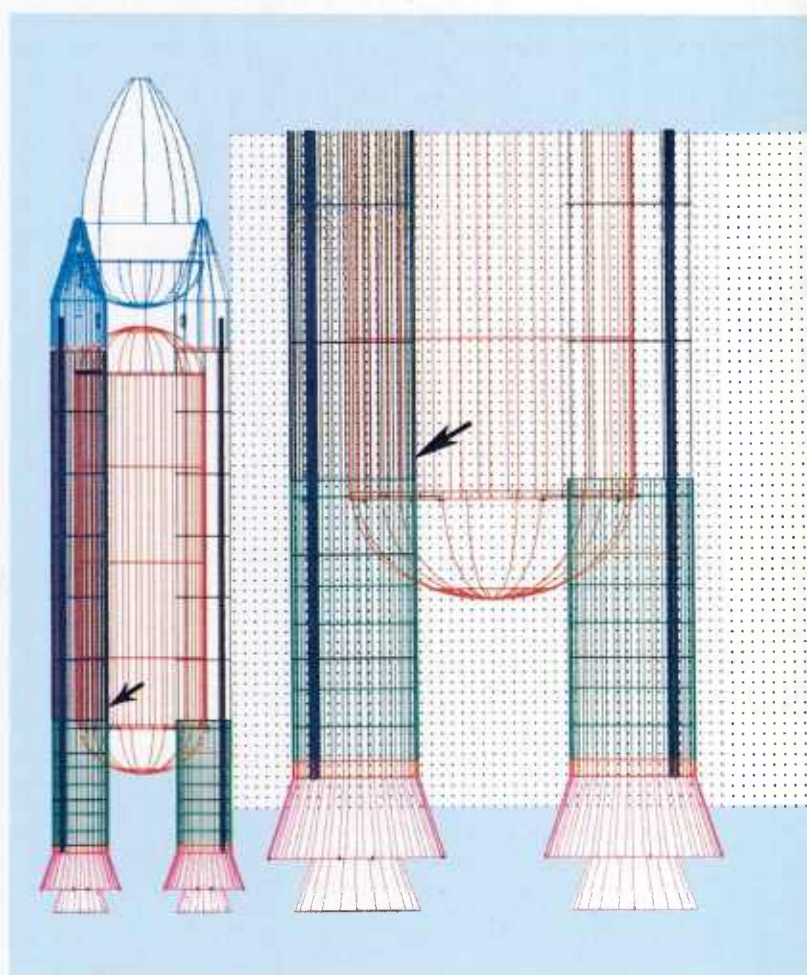
Multiple smoke puffs are visible in the photo above (arrows). They began at .836 seconds and continued through 2.500 seconds, occurring about 4 times a second. Upward motion of the vehicle caused the smoke to drift downward and blur into a single cloud. Smoke source is shown in the computer generated drawing (far right).

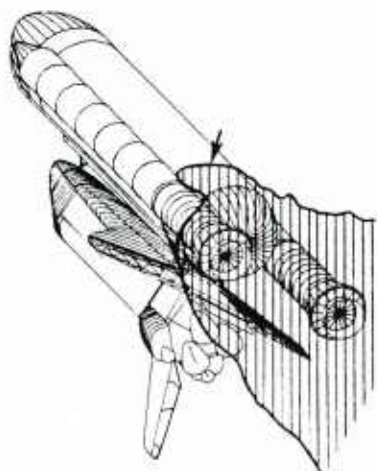
At 58.788 seconds, the first flicker of flame appeared. Barely visible above, it grew into a large plume and began to impinge on the External Tank at about 60 seconds. Flame is pinpointed in the computer drawing between the right booster and the tank, as in the case of earlier smoke puffs. At far right (arrow), vapor is seen escaping from the apparently breached External Tank.

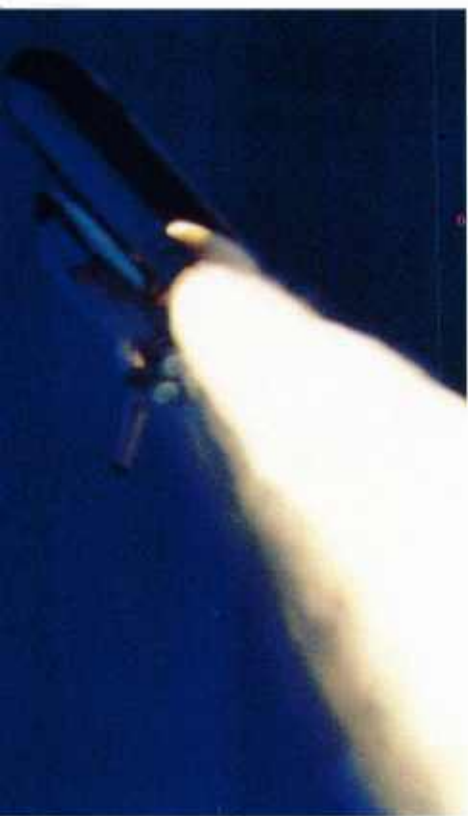
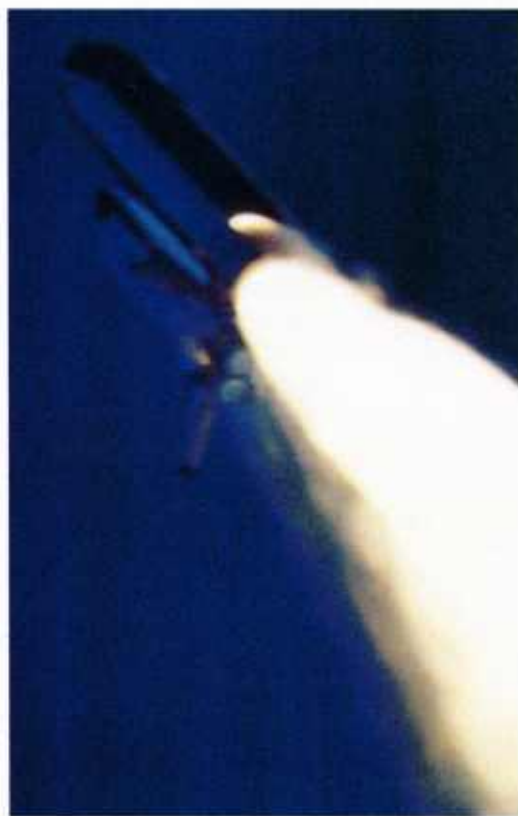
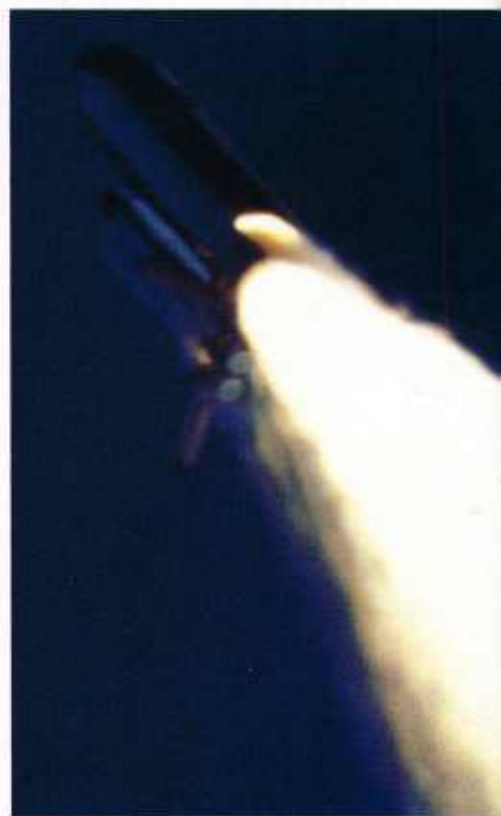
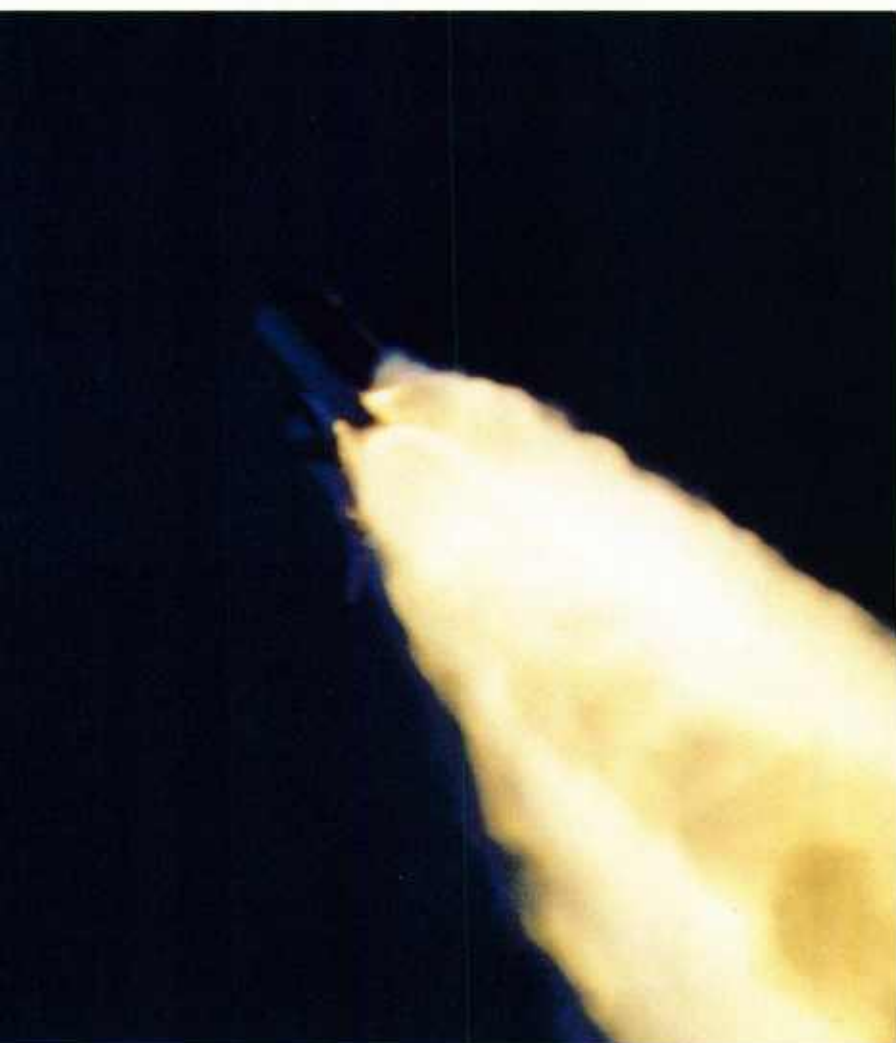
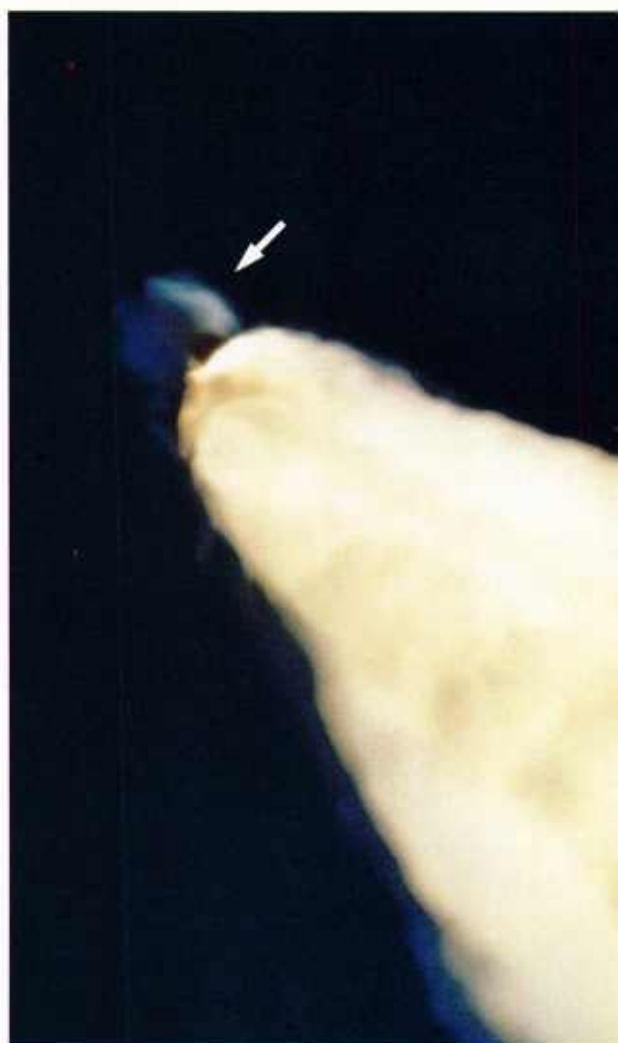
Camera views indicate the beginning of rupture of the liquid hydrogen and liquid oxygen tanks within the External Tank. A small flash (arrows above) intensified rapidly, then diminished. A second flash,

attributed to rupture of the liquid oxygen tank, occurred above the booster/tank forward attachment (below left) and grew in milliseconds to the maximum size indicated in the computer drawing.

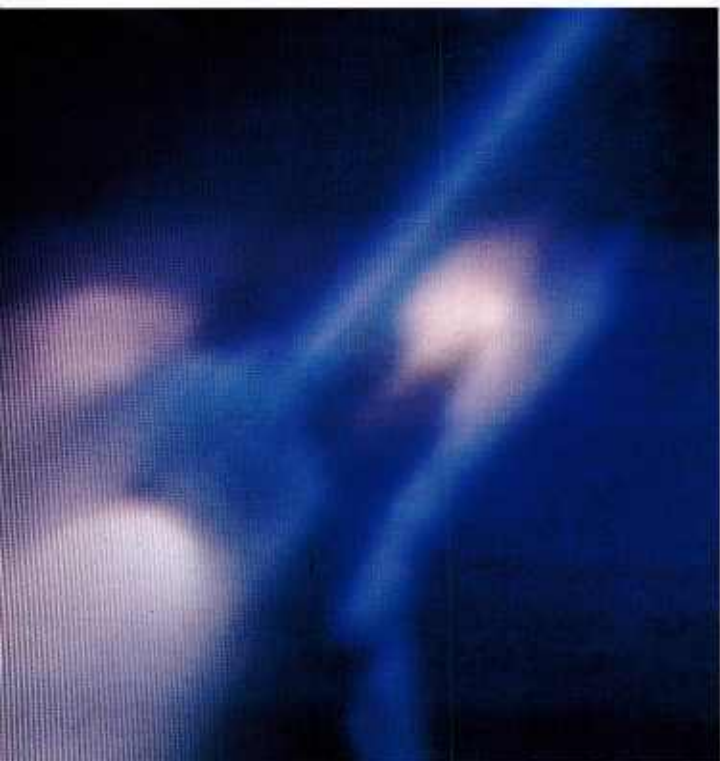
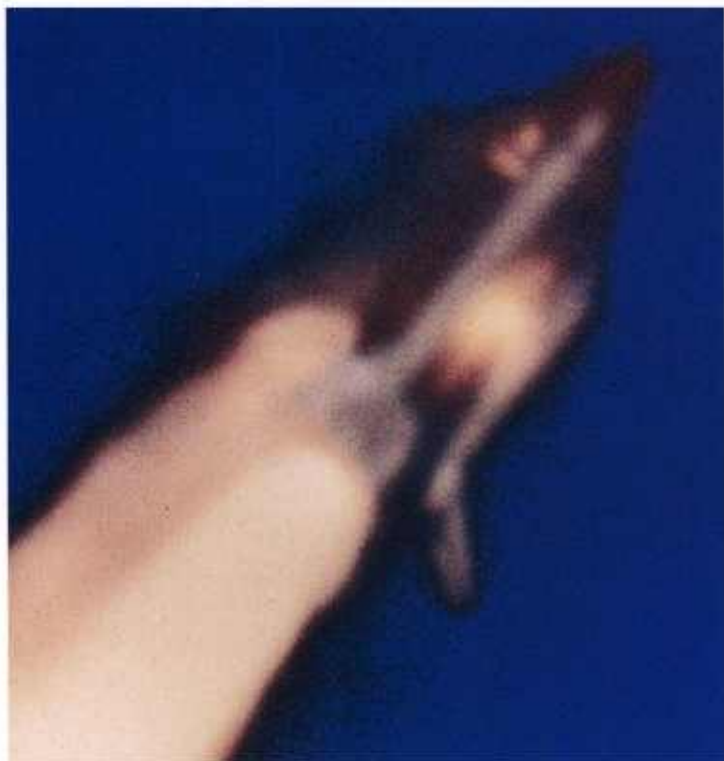
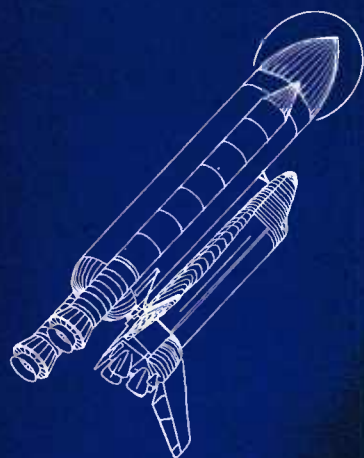
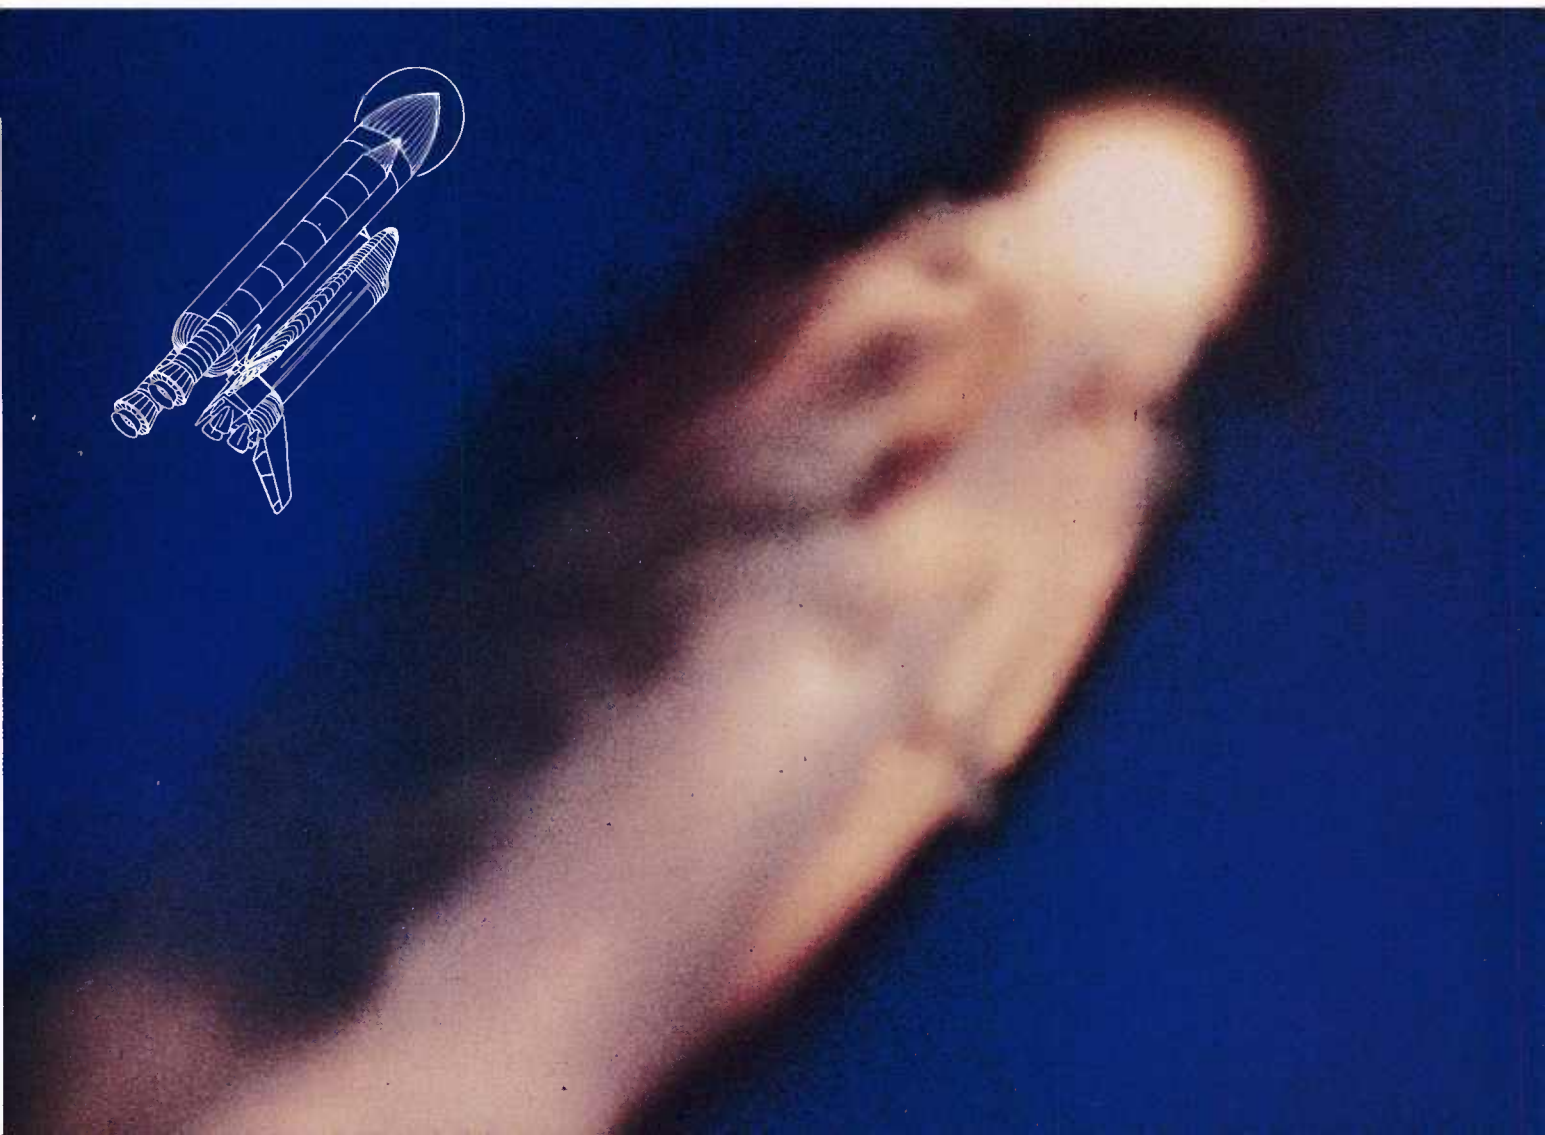
Structural breakup of the vehicle began at approximately 73 seconds. Fire spread very rapidly. Above, a bright flash (arrow) is evident near the nose of the Orbiter, suggesting spillage and ignition of the spacecraft's reaction control system propellants. At left, the two Solid Rocket Boosters thrust away from the fire, crisscrossing to form a "V." The right booster—identifiable by its failure plume—now to the left of its counterpart. At right, the boosters diverge farther; the External Tank wreckage is obscured by smoke and vapor. The Orbiter engines still firing, is visible at bottom center.

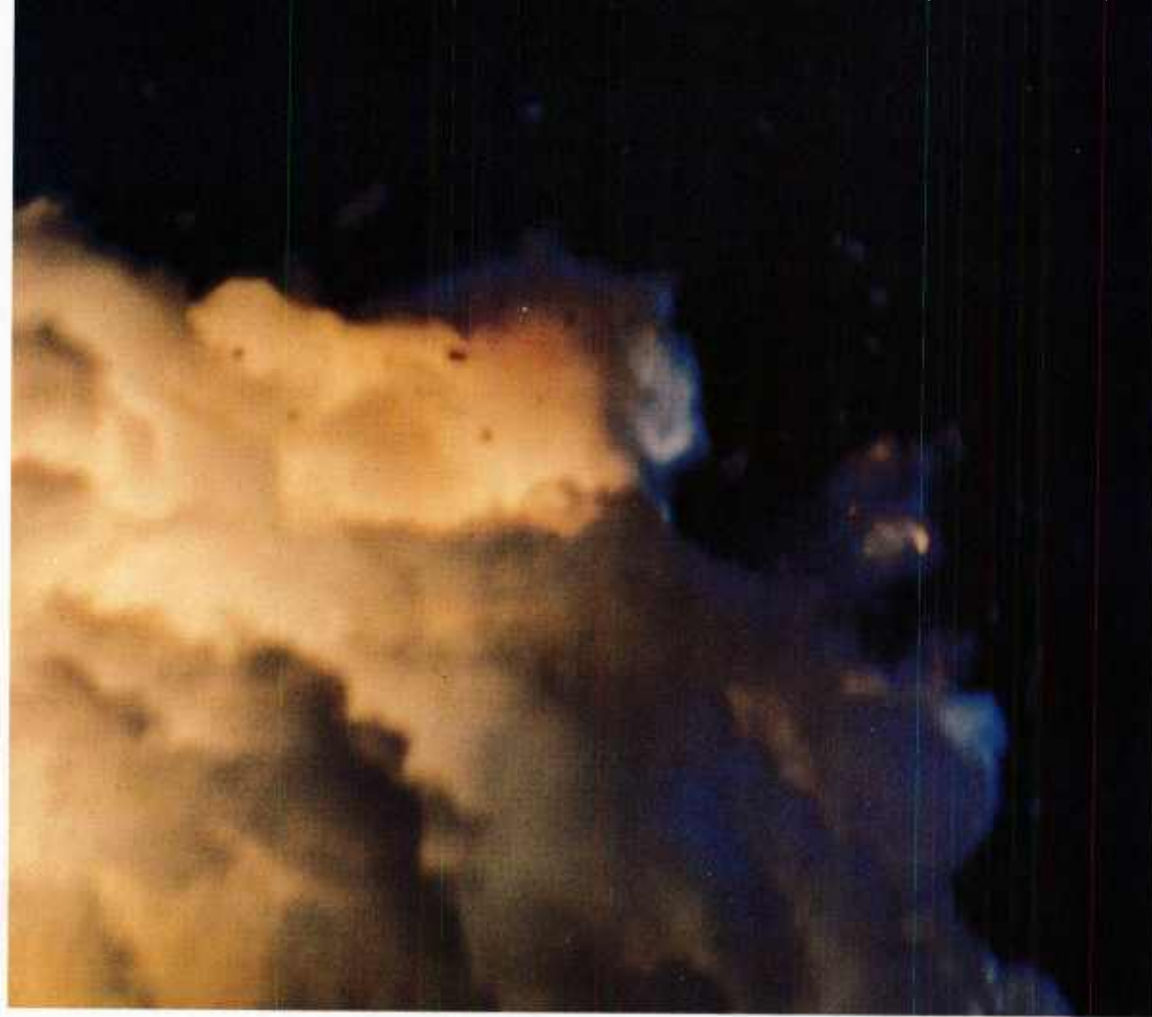
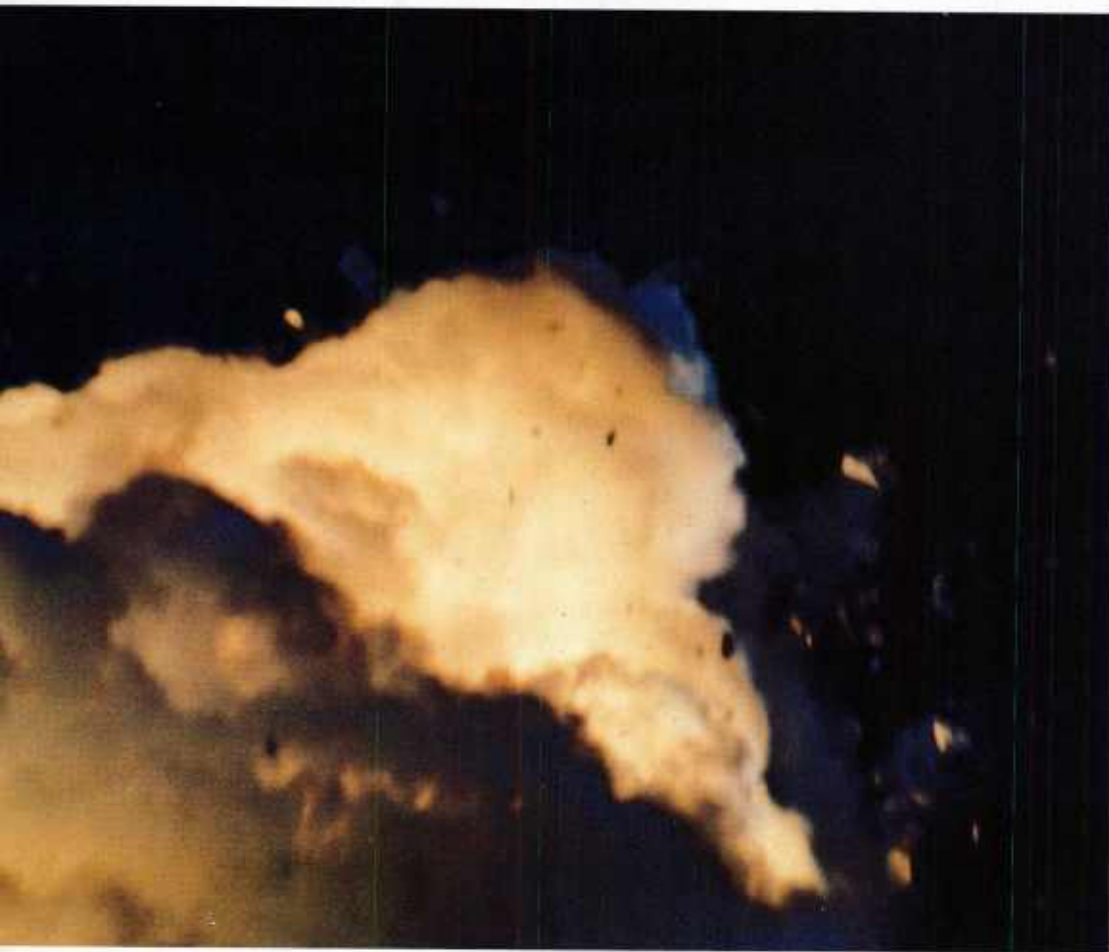
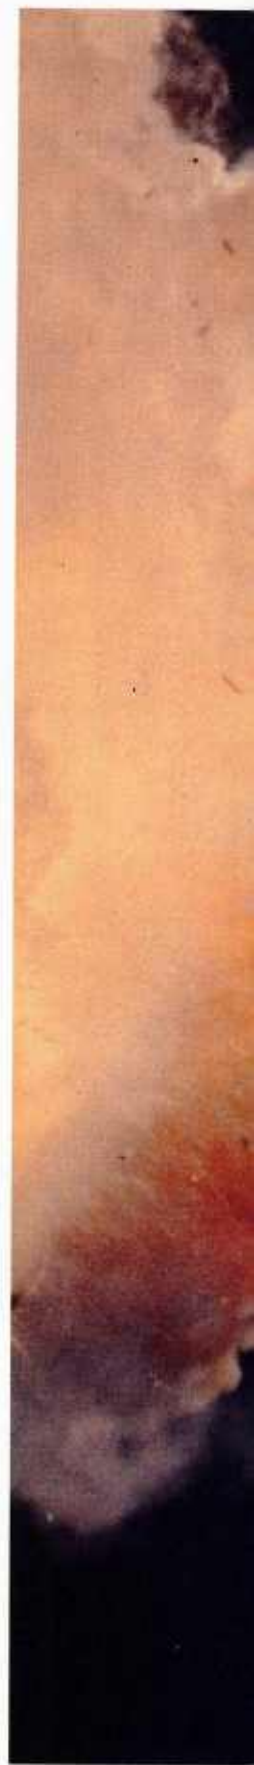
At about 76 seconds, unidentifiable fragments of the Shuttle vehicle can be seen tumbling against a background of fire, smoke and vaporized propellants from the External Tank (left). In the photo at right, the left booster (far right)

soars away, still thrusting. The reddish-brown cloud envelops the disintegrating Orbiter. The color is characteristic of the nitrogen tetroxide oxidizer in the Orbiter Reaction Control System propellant.

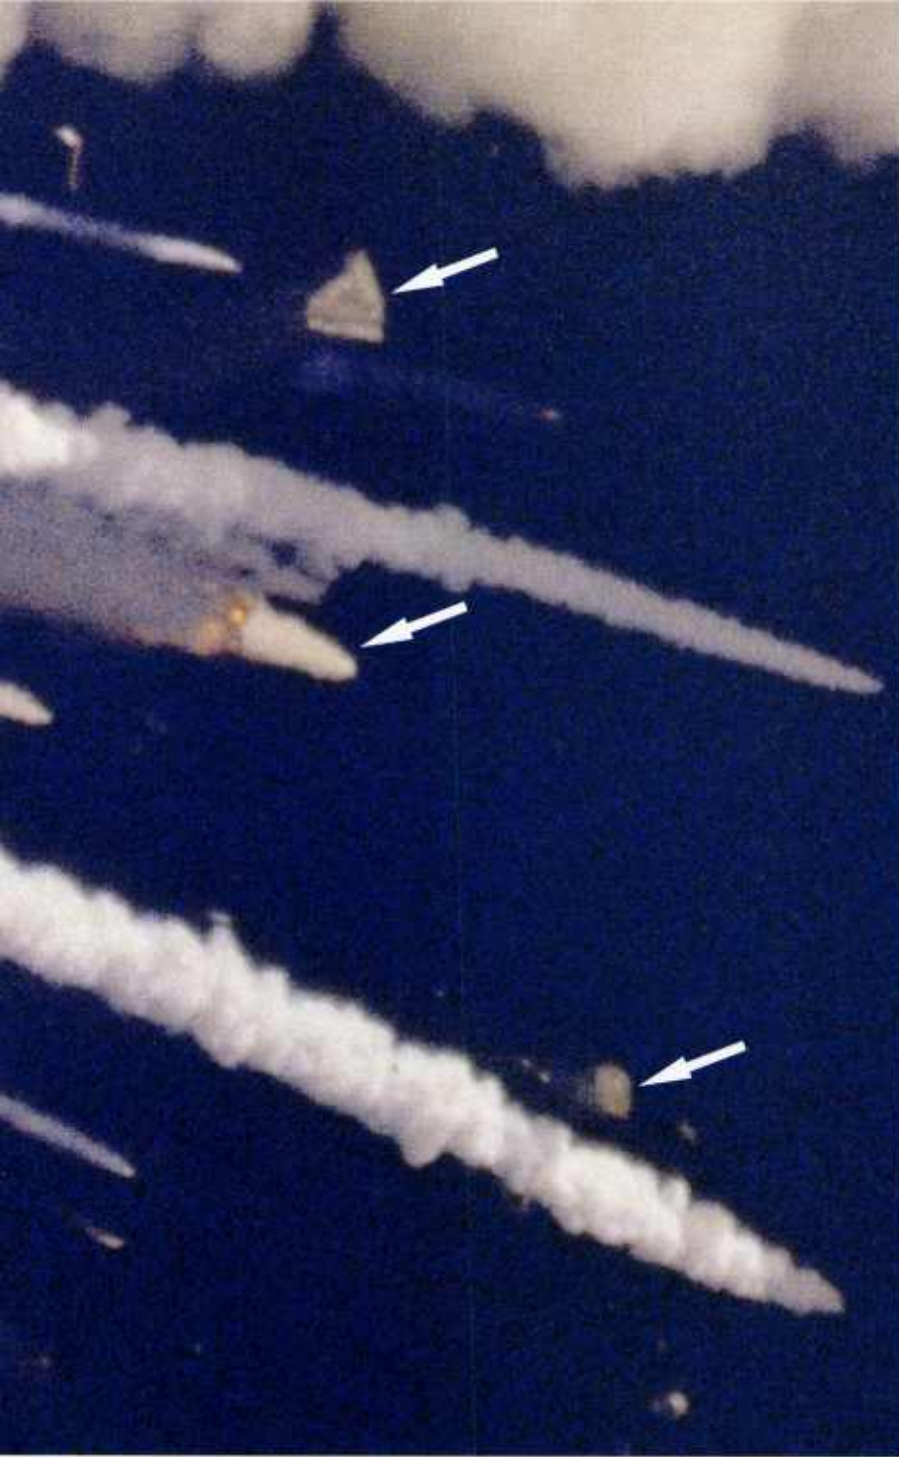
Hurling out of the fireball at 78 seconds (left) are the Orbiter's left wing (top arrow), the main engines (center arrow) and the forward fuselage (bottom arrow). In the photo below, it plunges Earthward, trailed by smoking fragments of Challenger.

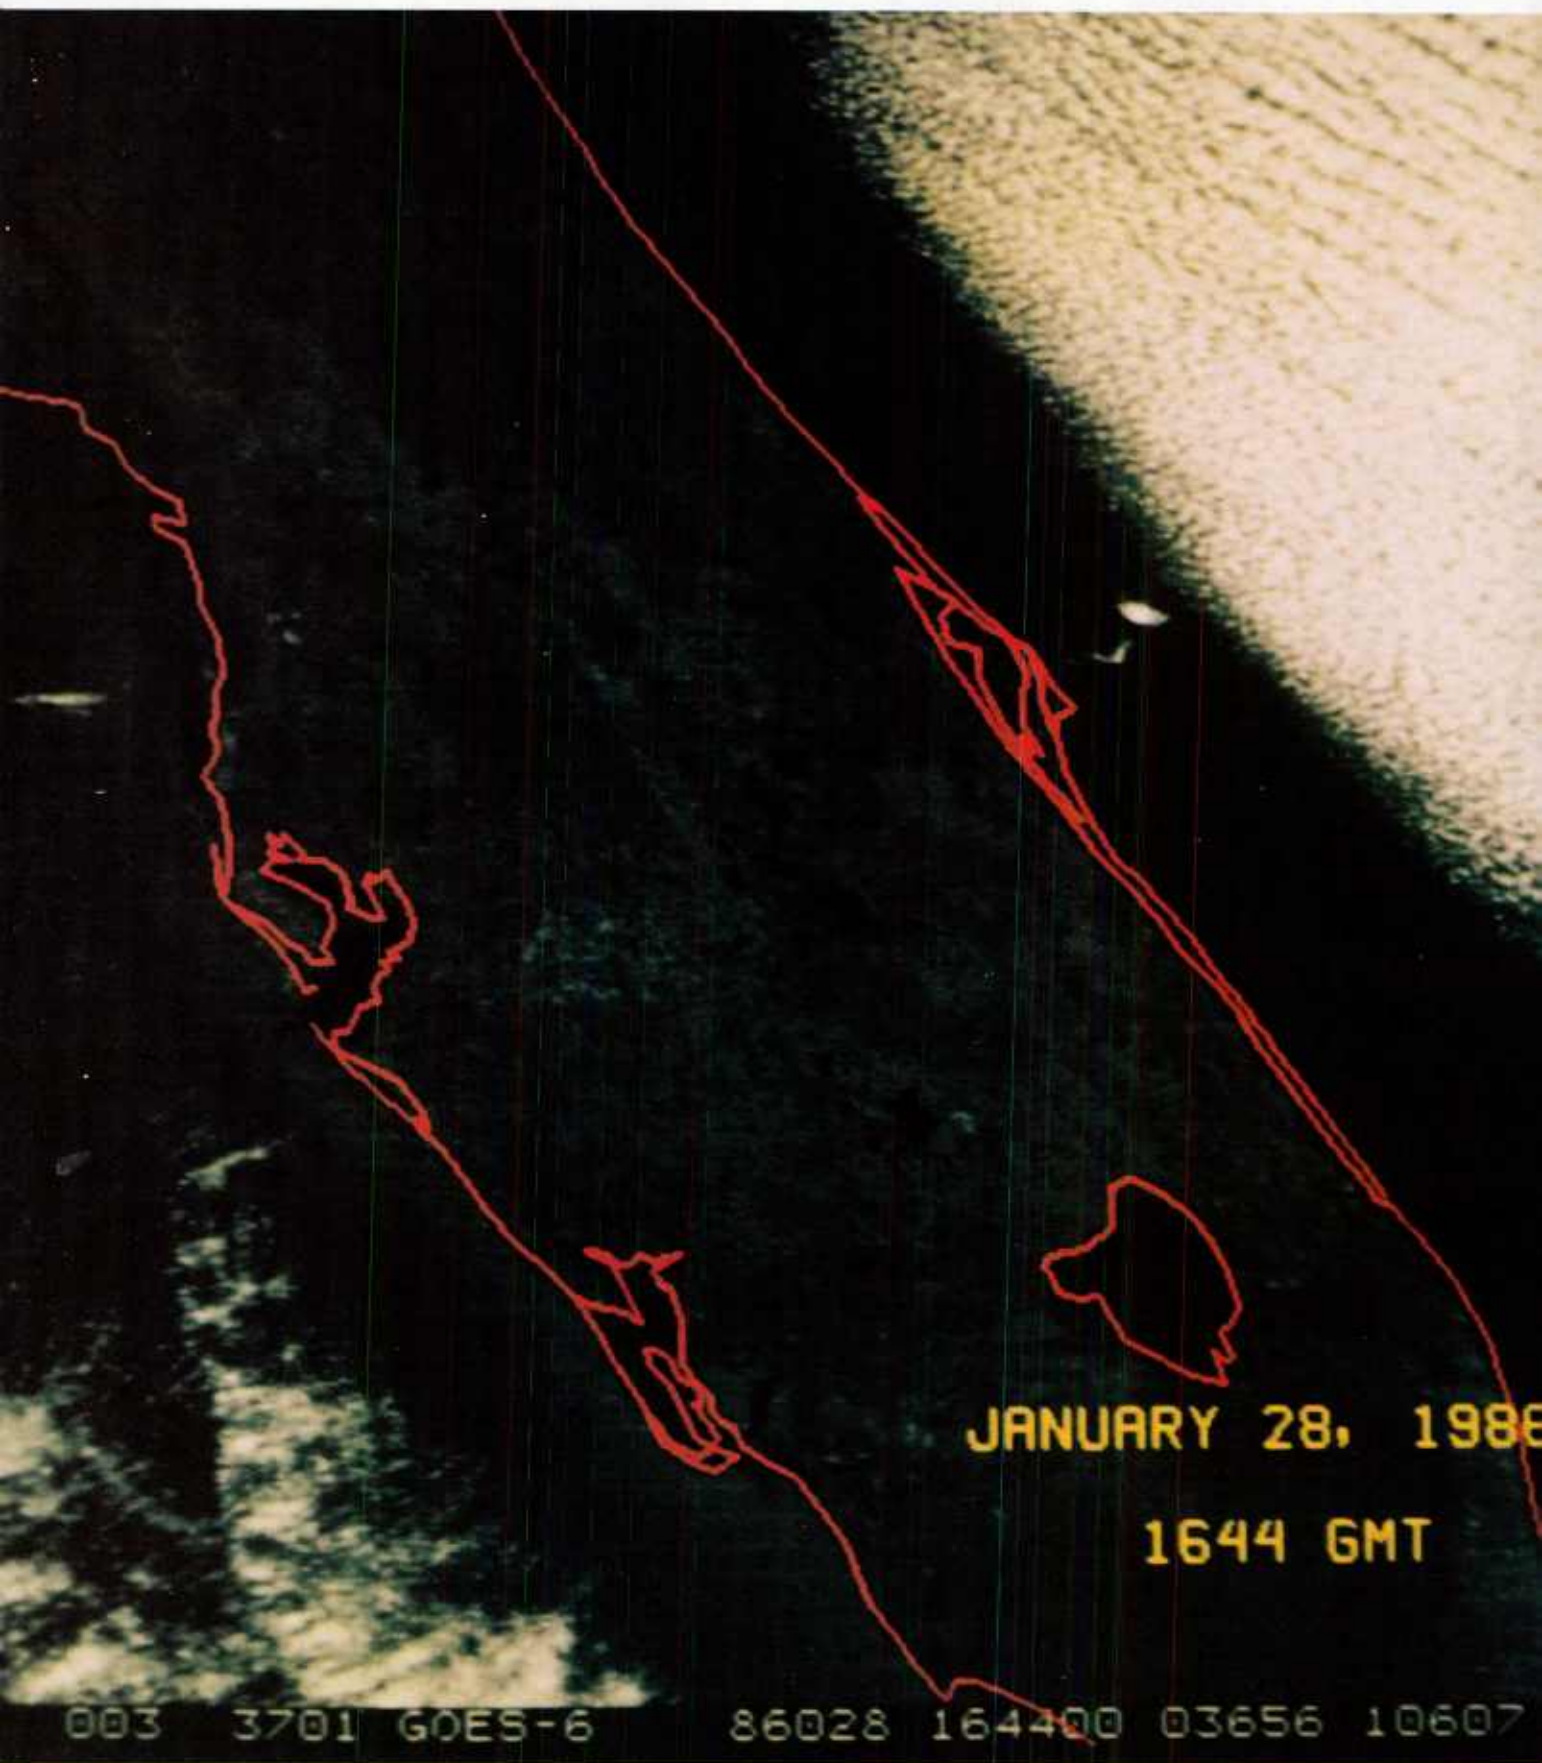
At 11:44 a.m. Eastern Standard Time, a GOES environment-monitoring satellite operated by the National Oceanic and Atmospheric Administration acquired this image of the smoke and vapor cloud from the 51-L accident. The coast of Florida is outlined in red.

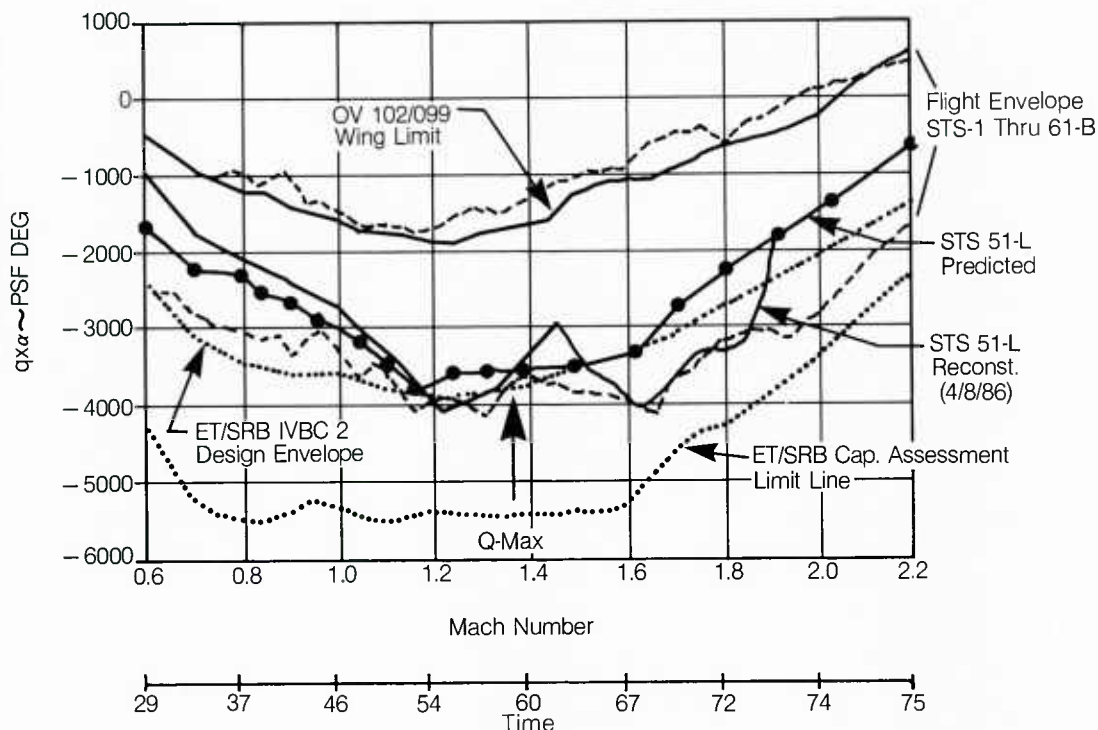
Figure 11

The Solid Rocket Motor field joint axial tension loads were substantially lower at maximum dynamic pressure than at lift off:  $11.6 \times 10^6$  pounds for the forward field joint and  $10.6 \times 10^6$  pounds for the aft field joint. Compared to the internal pressure loads, the dynamic variations due to wind shear were small—about  $\frac{1}{15}$  those of the pressure loads. *These loads were well below the design limit loads and were not considered the cause of the accident.*

The loads in the pitch plane are shown by the solid line marked "STS 51-L RECONST." The curve "STS 51-L PREDICTED" give the loads expected before the flight. The dashed lines show the limit of experience from STS-1 through 61-B. The present design limits are the two lines marked "OV

102/099 WING LIMIT" above, and "ET/SRB CAP. ASSESSMENT LIMIT LINE" below. (After STS-6, the wing was strengthened. The previous design limits were "ET/SRB IVBC 2 DESIGN ENVELOPE" below, and a curve in the positive region of  $q \times \alpha$  above)

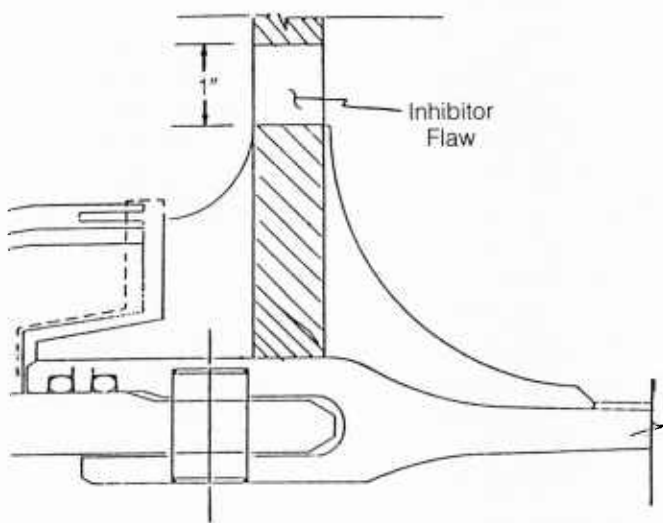
Figure 12

Sketch shows location of assumed inhibitor flaw used in eliminating such a problem as a possible cause.

Evaluation of potential insulation or inhibitor (see Figure 12) flaws against the three criteria above resulted in elimination of all candidates except a defect in the forward-facing inhibitor. This potential failure mode was evaluated by assuming a 1-inch-diameter hole in the inhibitor. Analysis indicated that the change in motor internal pressure resulting from this failure would probably not be detected. However, an erosion rate substantially higher than the observed values would be required to burn through the membrane by 58 seconds. In addition, the assumed flaw is unlikely since the inhibitor is constructed by vulcanizing eight individual plies of the material. Subsequent damage of the magnitude required is improbable and would be easily detected.

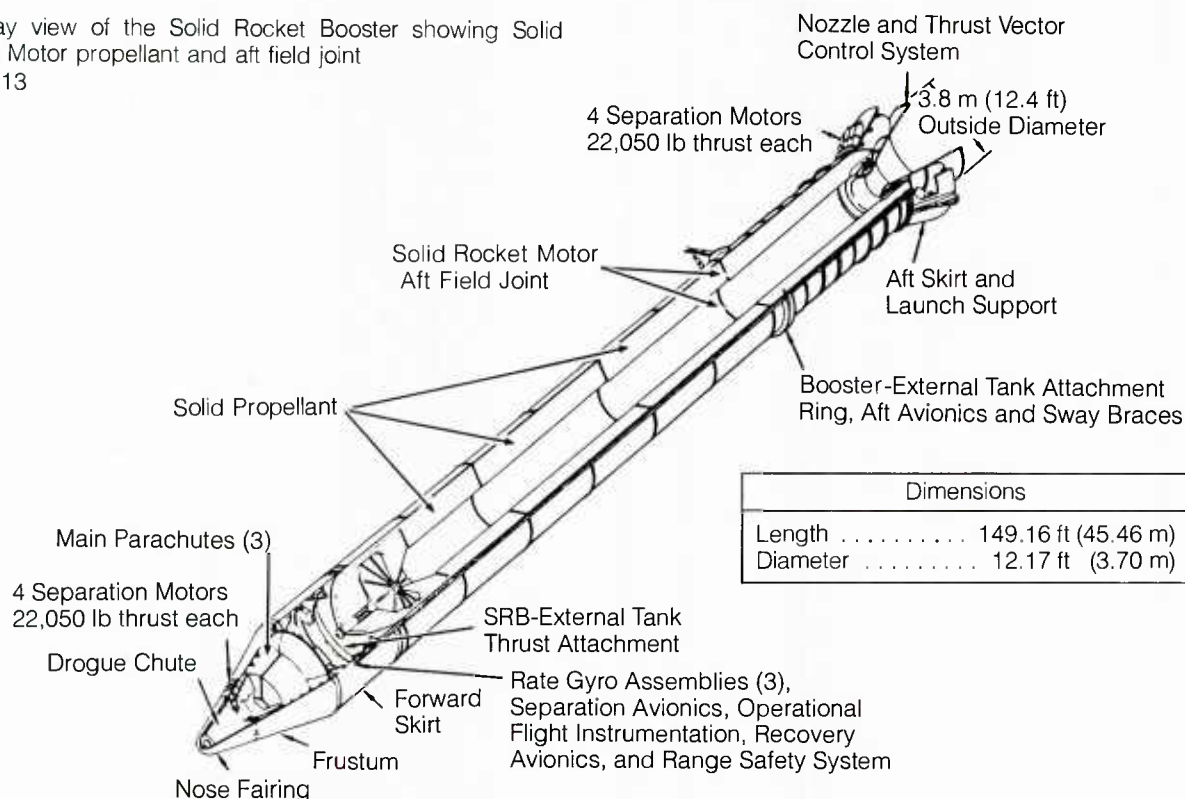
Cutaway view of the Solid Rocket Booster showing Solid Rocket Motor propellant and aft field joint  
Figure 13

Subsequent to these evaluations, sections of the right Solid Rocket Motor case containing holes burned through in the area of the aft field joint were recovered. *Assessments of the sections do not support a failure that started in the membrane and progressed slowly to the joint; or one that started in the membrane and grew rapidly the length of the Solid Rocket Motor segment.*

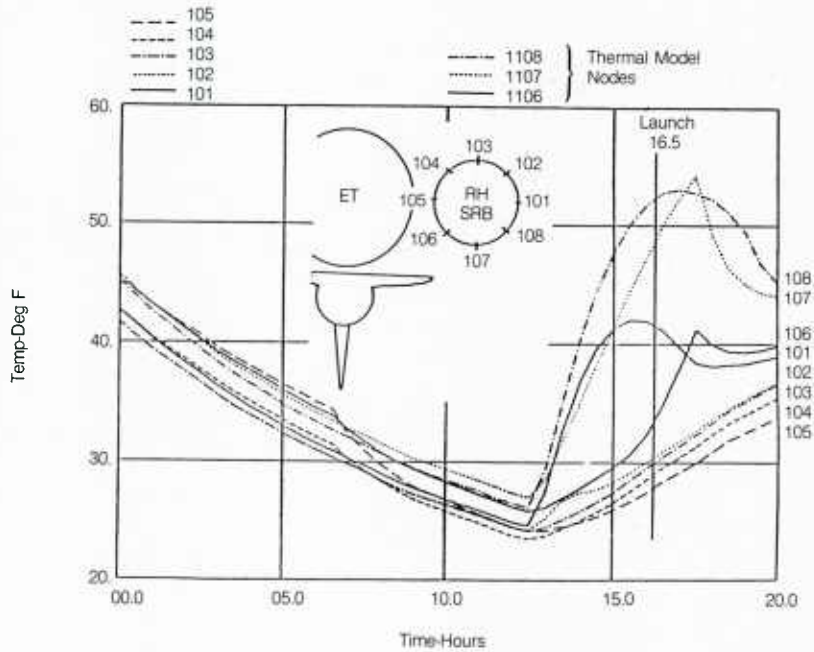
Figure 20  
Temperature model for 51-L right solid booster aft segment circumferential positions from 16.5 hours prior to launch to 3.5 hours after launch.

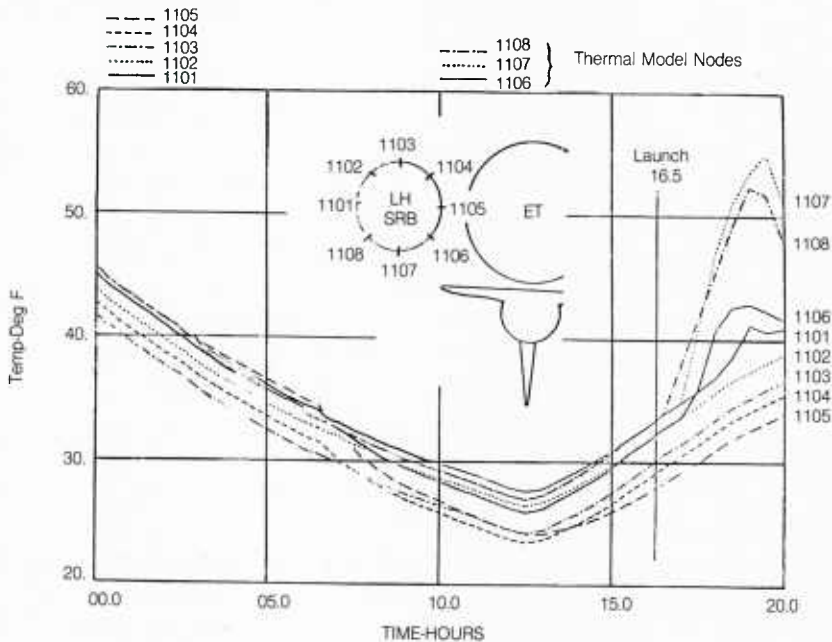
Figure 21  
Temperature model for 51-L left solid booster aft segment circumferential positions from 16.5 hours prior to launch until 3.5 hours after launch.

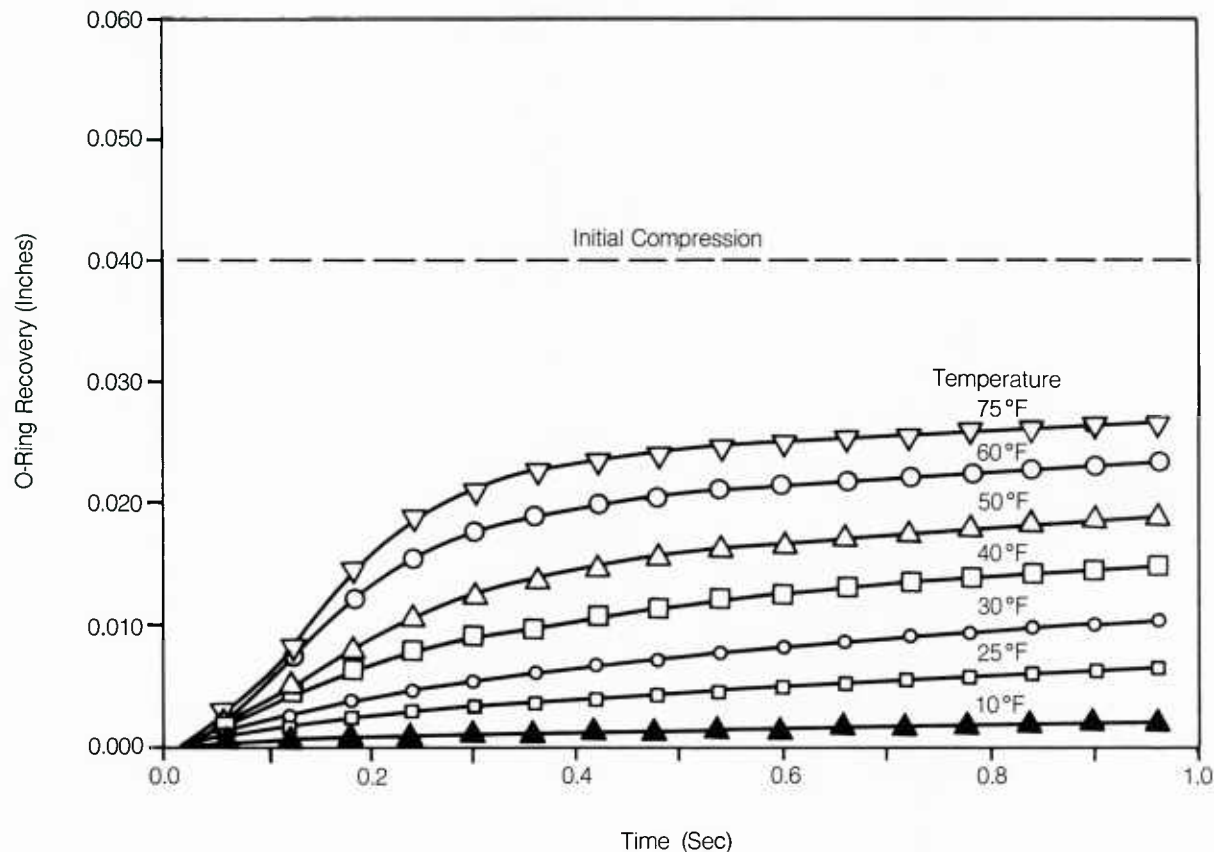
Consistent results from numerous O-ring tests have shown a resiliency degradation with reduced temperatures. Figure 23 provides O-ring recovery from 0.040 inches of initial compression versus time. This shows how quickly an O-ring will move back towards its uncompressed shape at temperatures ranging from 10 to 75 degrees Fahrenheit. When these data are compared with the gap openings versus time from Figure 17, it can be seen that the O-rings will not track or

Graph plots O-ring shape recovery in inches against time in seconds for a variety of temperatures.
